# Manhole Inspection Summary

Manhole # S11EE2025MH

Insp Date: **10/10/06 11:32 AM**

**Location** Address: **2301 CROSS COUNTRY BLVD**

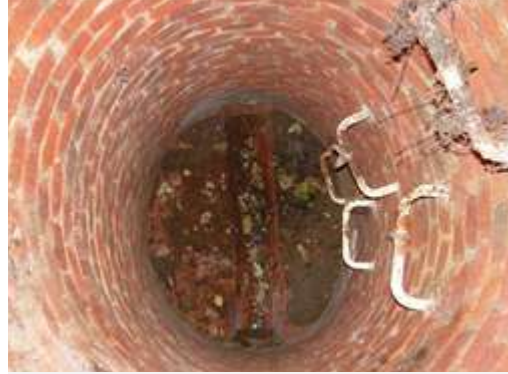
Top View

Infiltration: ☐ None ☒ **Joint** ☐ Cracks ☒ **Mortar** ☐ Roots ☐ Wall

Infiltration: ☐ None ☐ Joint ☐ Cracks ☒ **Mortar** ☐ Roots ☒ **Wall**

**Surcharge** ☒ **Evidence Of Surcharge** Depth: **3** (ft.) ☐ Active Surcharge Present

Adjustment and Corbel infiltration.  
Evidence of surcharge - Bench debris.

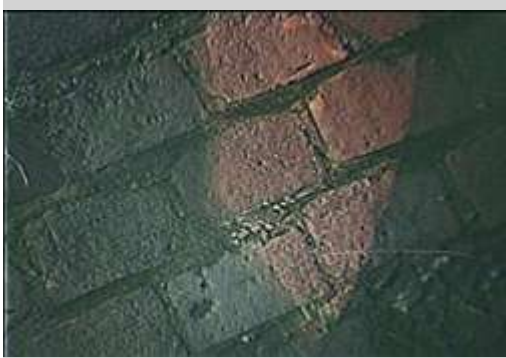
Defect

Adjustment infiltration.

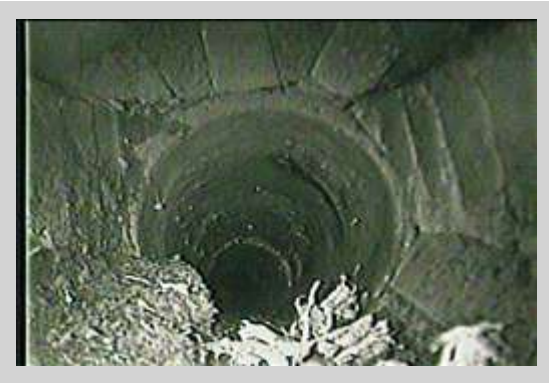
### 8 in. Circular Gravity Sewer Pipe Out @ 12 O'Clock

Comments **The O12 pipe picture shows Channel root intrusion.**

Condition: ☐ Sound ☐ Cracked ☒ **Root Intrusion** ☐ Deteriorated ☐ Leaks ☐ Debris

Channel root intrusion.

Infiltration: **Evidence** Pipe Seal Cond: **Roots**
